Hazardous Materials Building Assessment

1 King Place
Meriden, CT

November 4, 2014

**Re: Hazardous Materials Building Assessment-
Former Veteran's Memorial Hospital
1 King Place, Meriden, CT**
Fuss & O'Neill EnviroScience Project No. 20120232.A7E

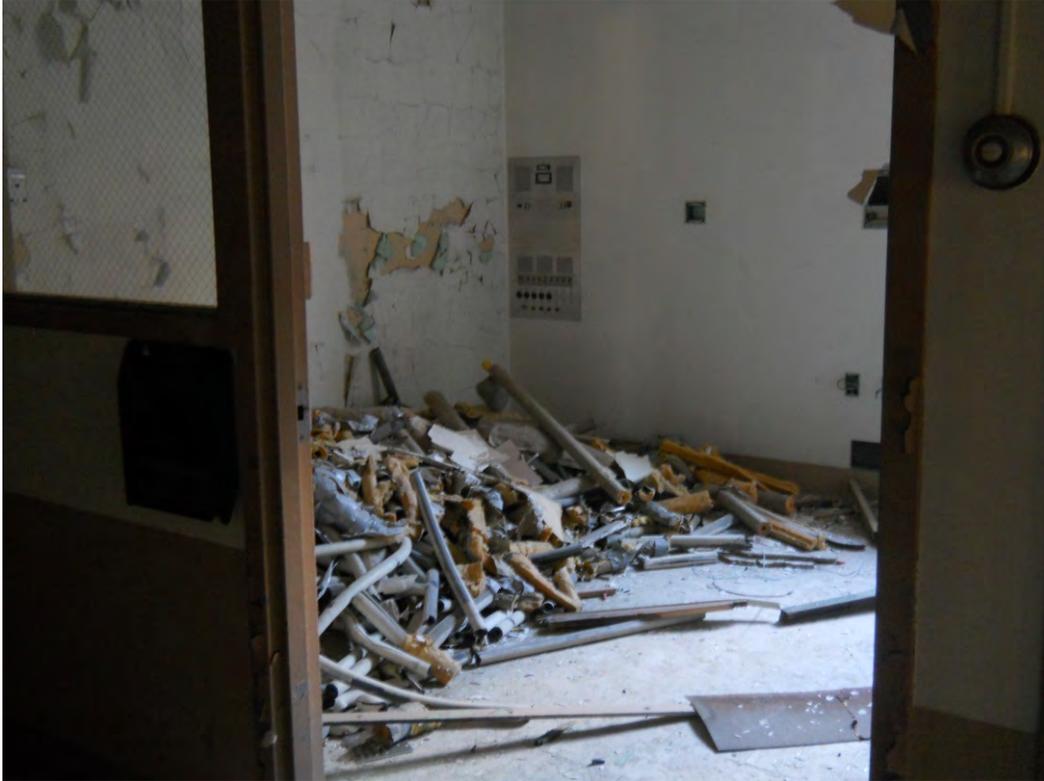
Photo 1 – Debris pile of various types of pipe insulation

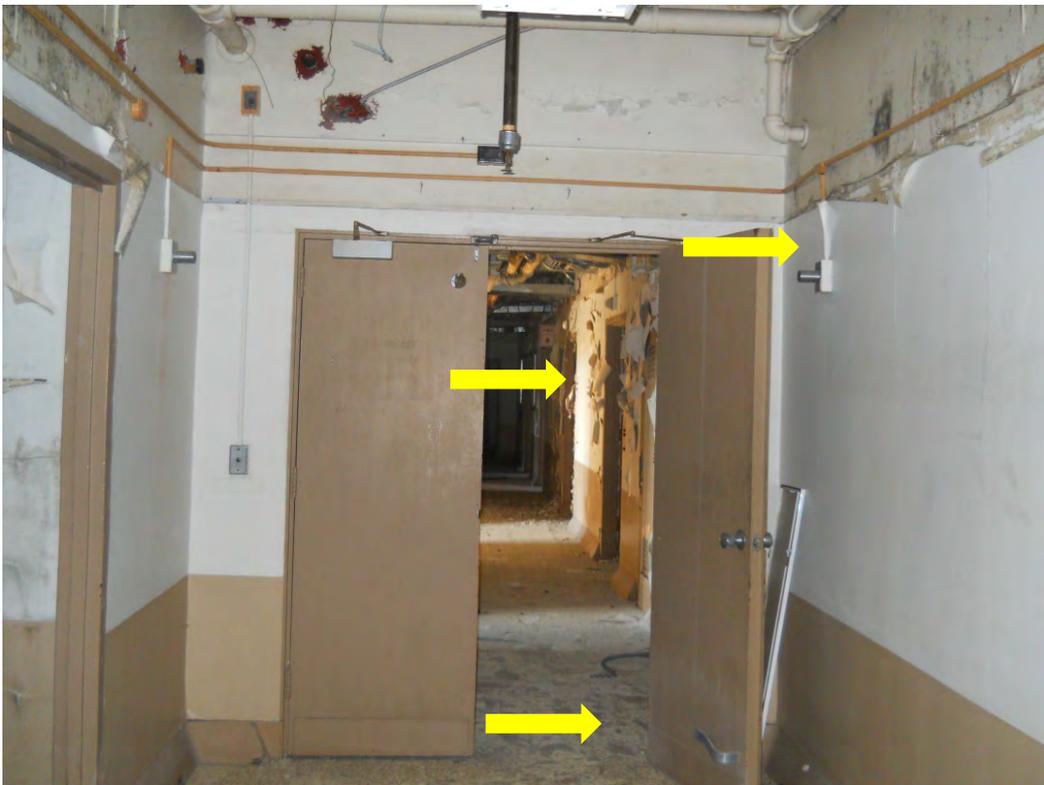
Photo 2 – Deteriorated wall finishings and flooring throughout hallway

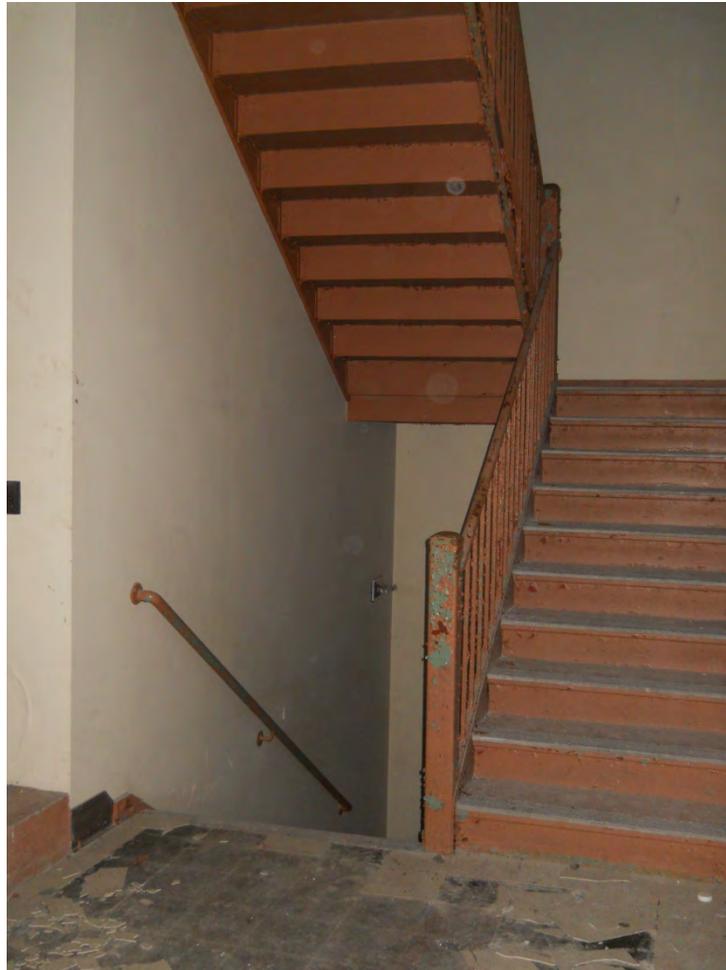
EnviroScience field staff observed potential lead-based paint chips on the floor from the deteriorated painted surfaces within the stairwells and mechanical spaces. No lead-based paint determination was performed at the time of the inspection. We recommended analyzes of lead paint chips prior to disposal of building materials.

Photo 3 – Typical Stairwell with deteriorated painted surfaces and floor tile

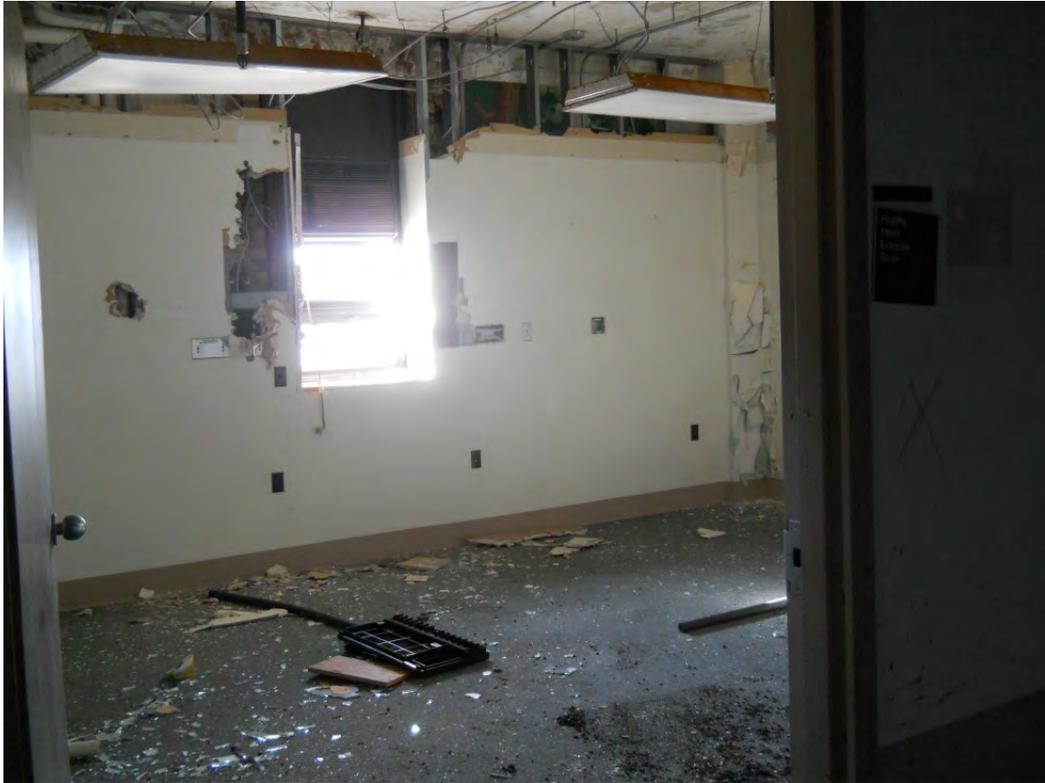
Photo 4 – Debris throughout room

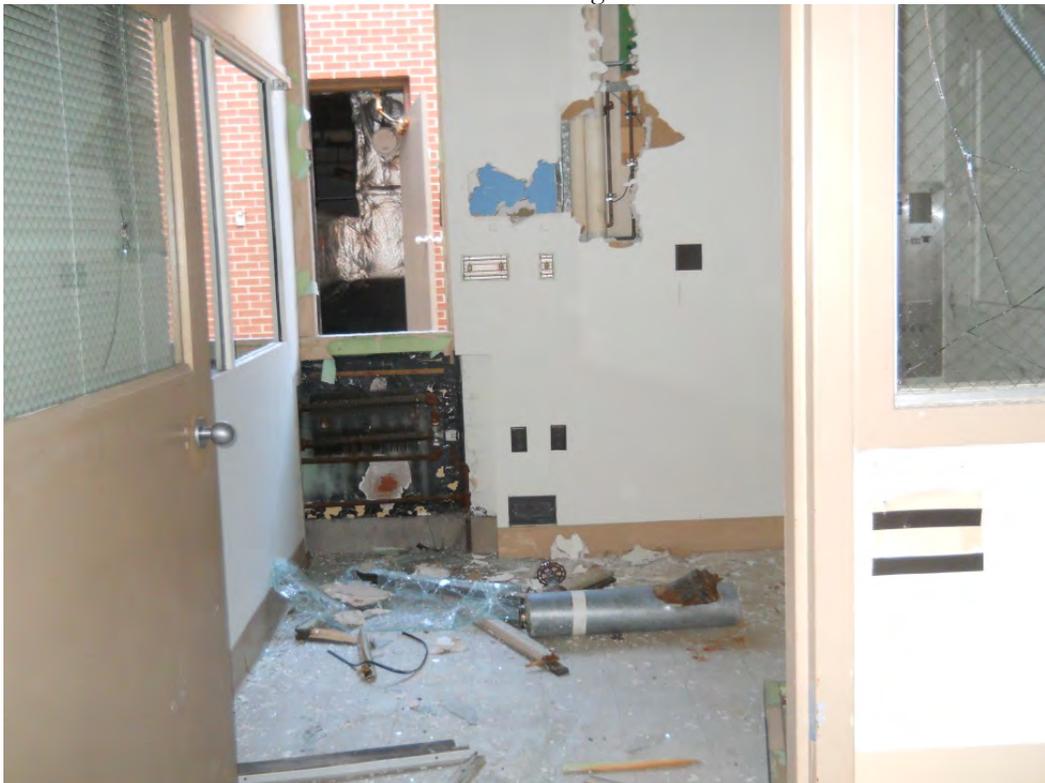
Photo 5 – Debris pile on floor
