Prepared for:
City of Meriden, Connecticut

Prepared by:
AECOM
Rocky Hill, Connecticut
60430270
October 2015

Assessment of Building Components Asbestos, PCB, and Lead Impacts Mills Memorial Housing Complex Low Rise 3, 52 & 58 Mill Street, Meriden, Connecticut 06450

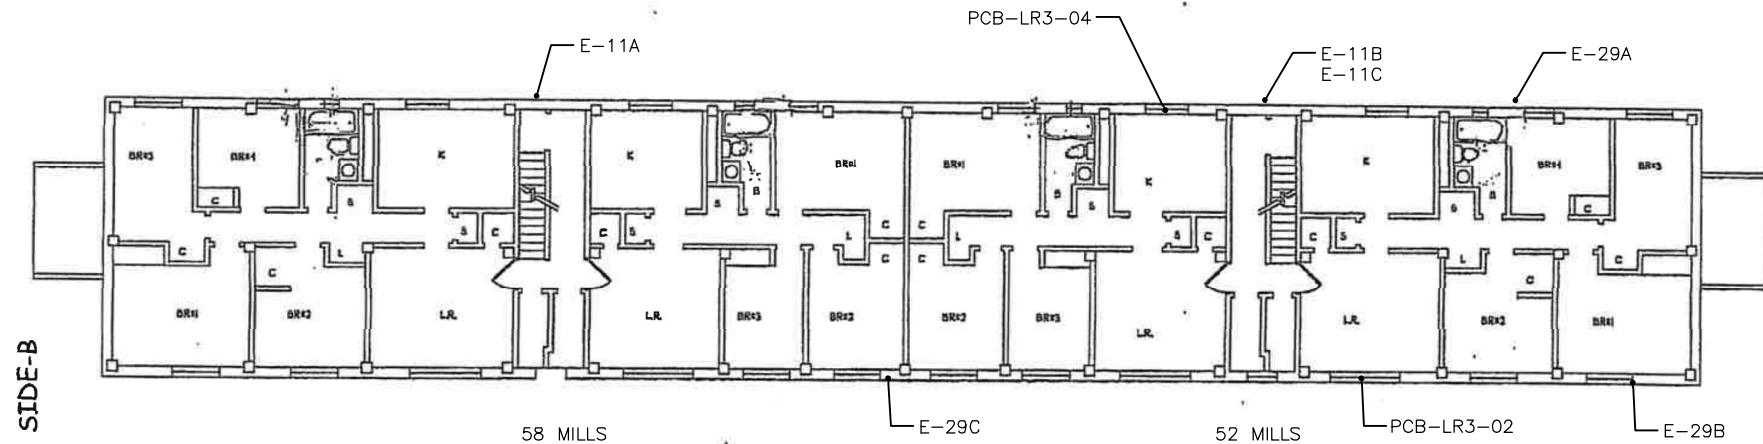
FIGURE 1
SAMPLE LOCATION PLAN

LOW RISE 3
EXTERIOR

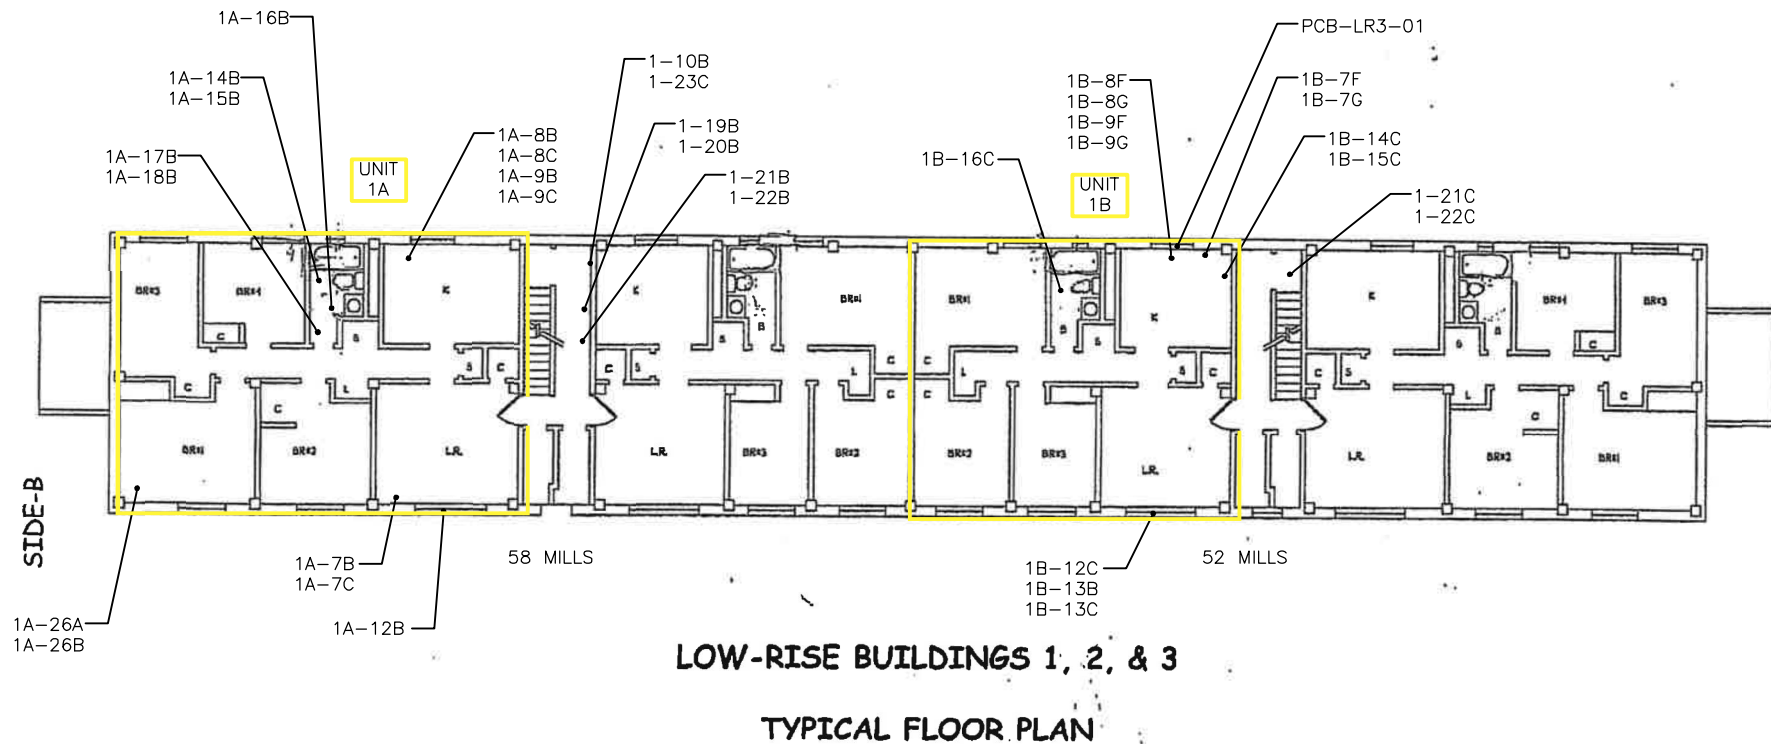
FIGURE 2
 SAMPLE LOCATION PLAN

LOW RISE 3
 FLOOR 1

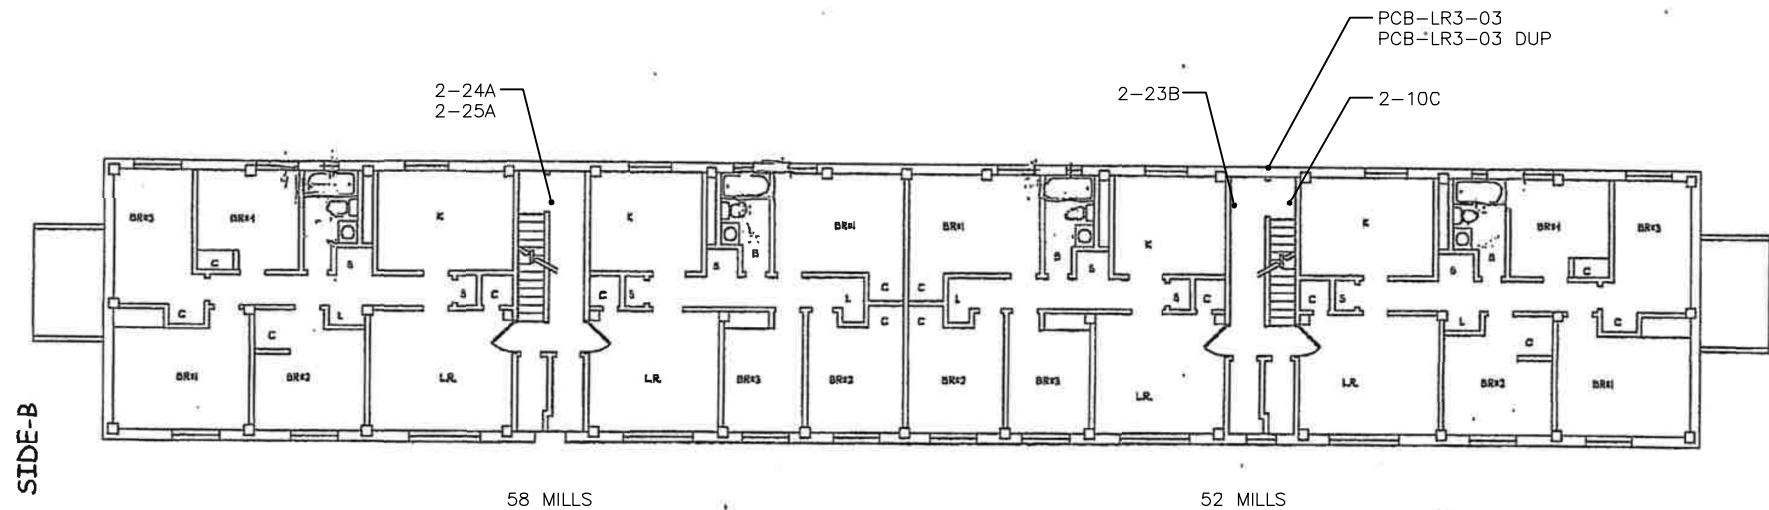
FIGURE 3
SAMPLE LOCATION PLAN

LOW RISE 3
FLOOR 2

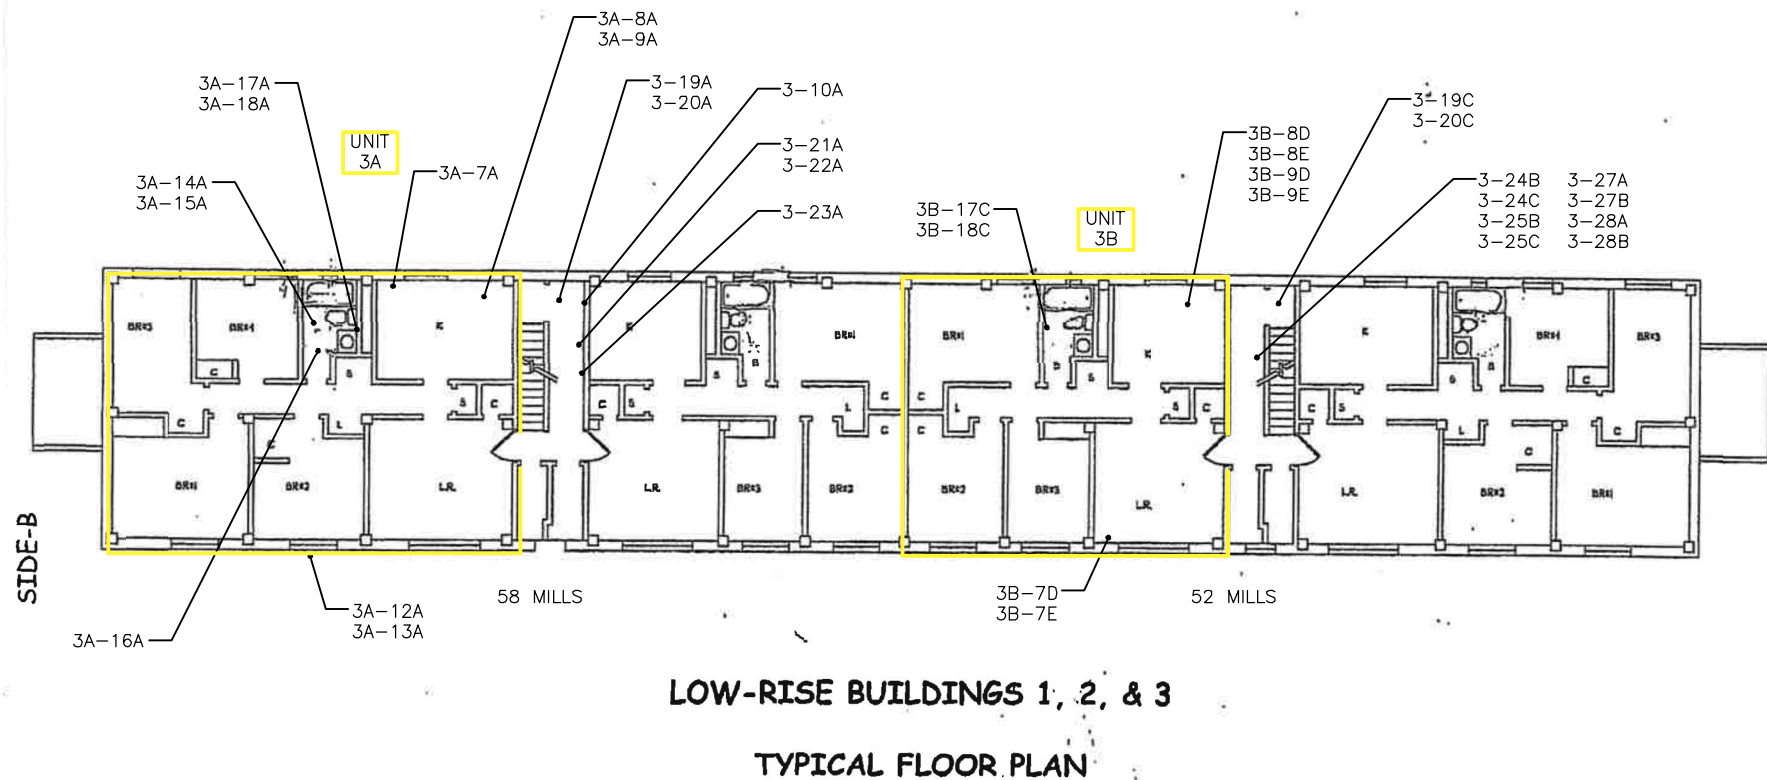
FIGURE 4
 SAMPLE LOCATION PLAN

LOW RISE 3
 FLOOR 3
