**Re: ECAF- 77 Cooper Street, Meriden, CT- Waiver of Filing Fee Pursuant
to the PA 11-141**

ENVIRONMENTAL CONDITION ASSESSMENT FORM (ECAF)

FIGURE 1 - SITE LOCATION MAP
 FORMER INTERNATIONAL SILVER COMPANY SITE
 77 Cooper Street & 104 Butler Street
 Meriden, Connecticut

CITY OF MERIDEN, CONNECTICUT
 INTERNATIONAL SILVER COMPANY, FACTORY H
FIGURE 2 – AOCs AND CIDEP
 STABILIZATION AREAS
 SUPPLEMENTAL INVESTIGATION AND SOIL REUSE EVALUATION
 SCALE: AS NOTED DATE: JULY 2009

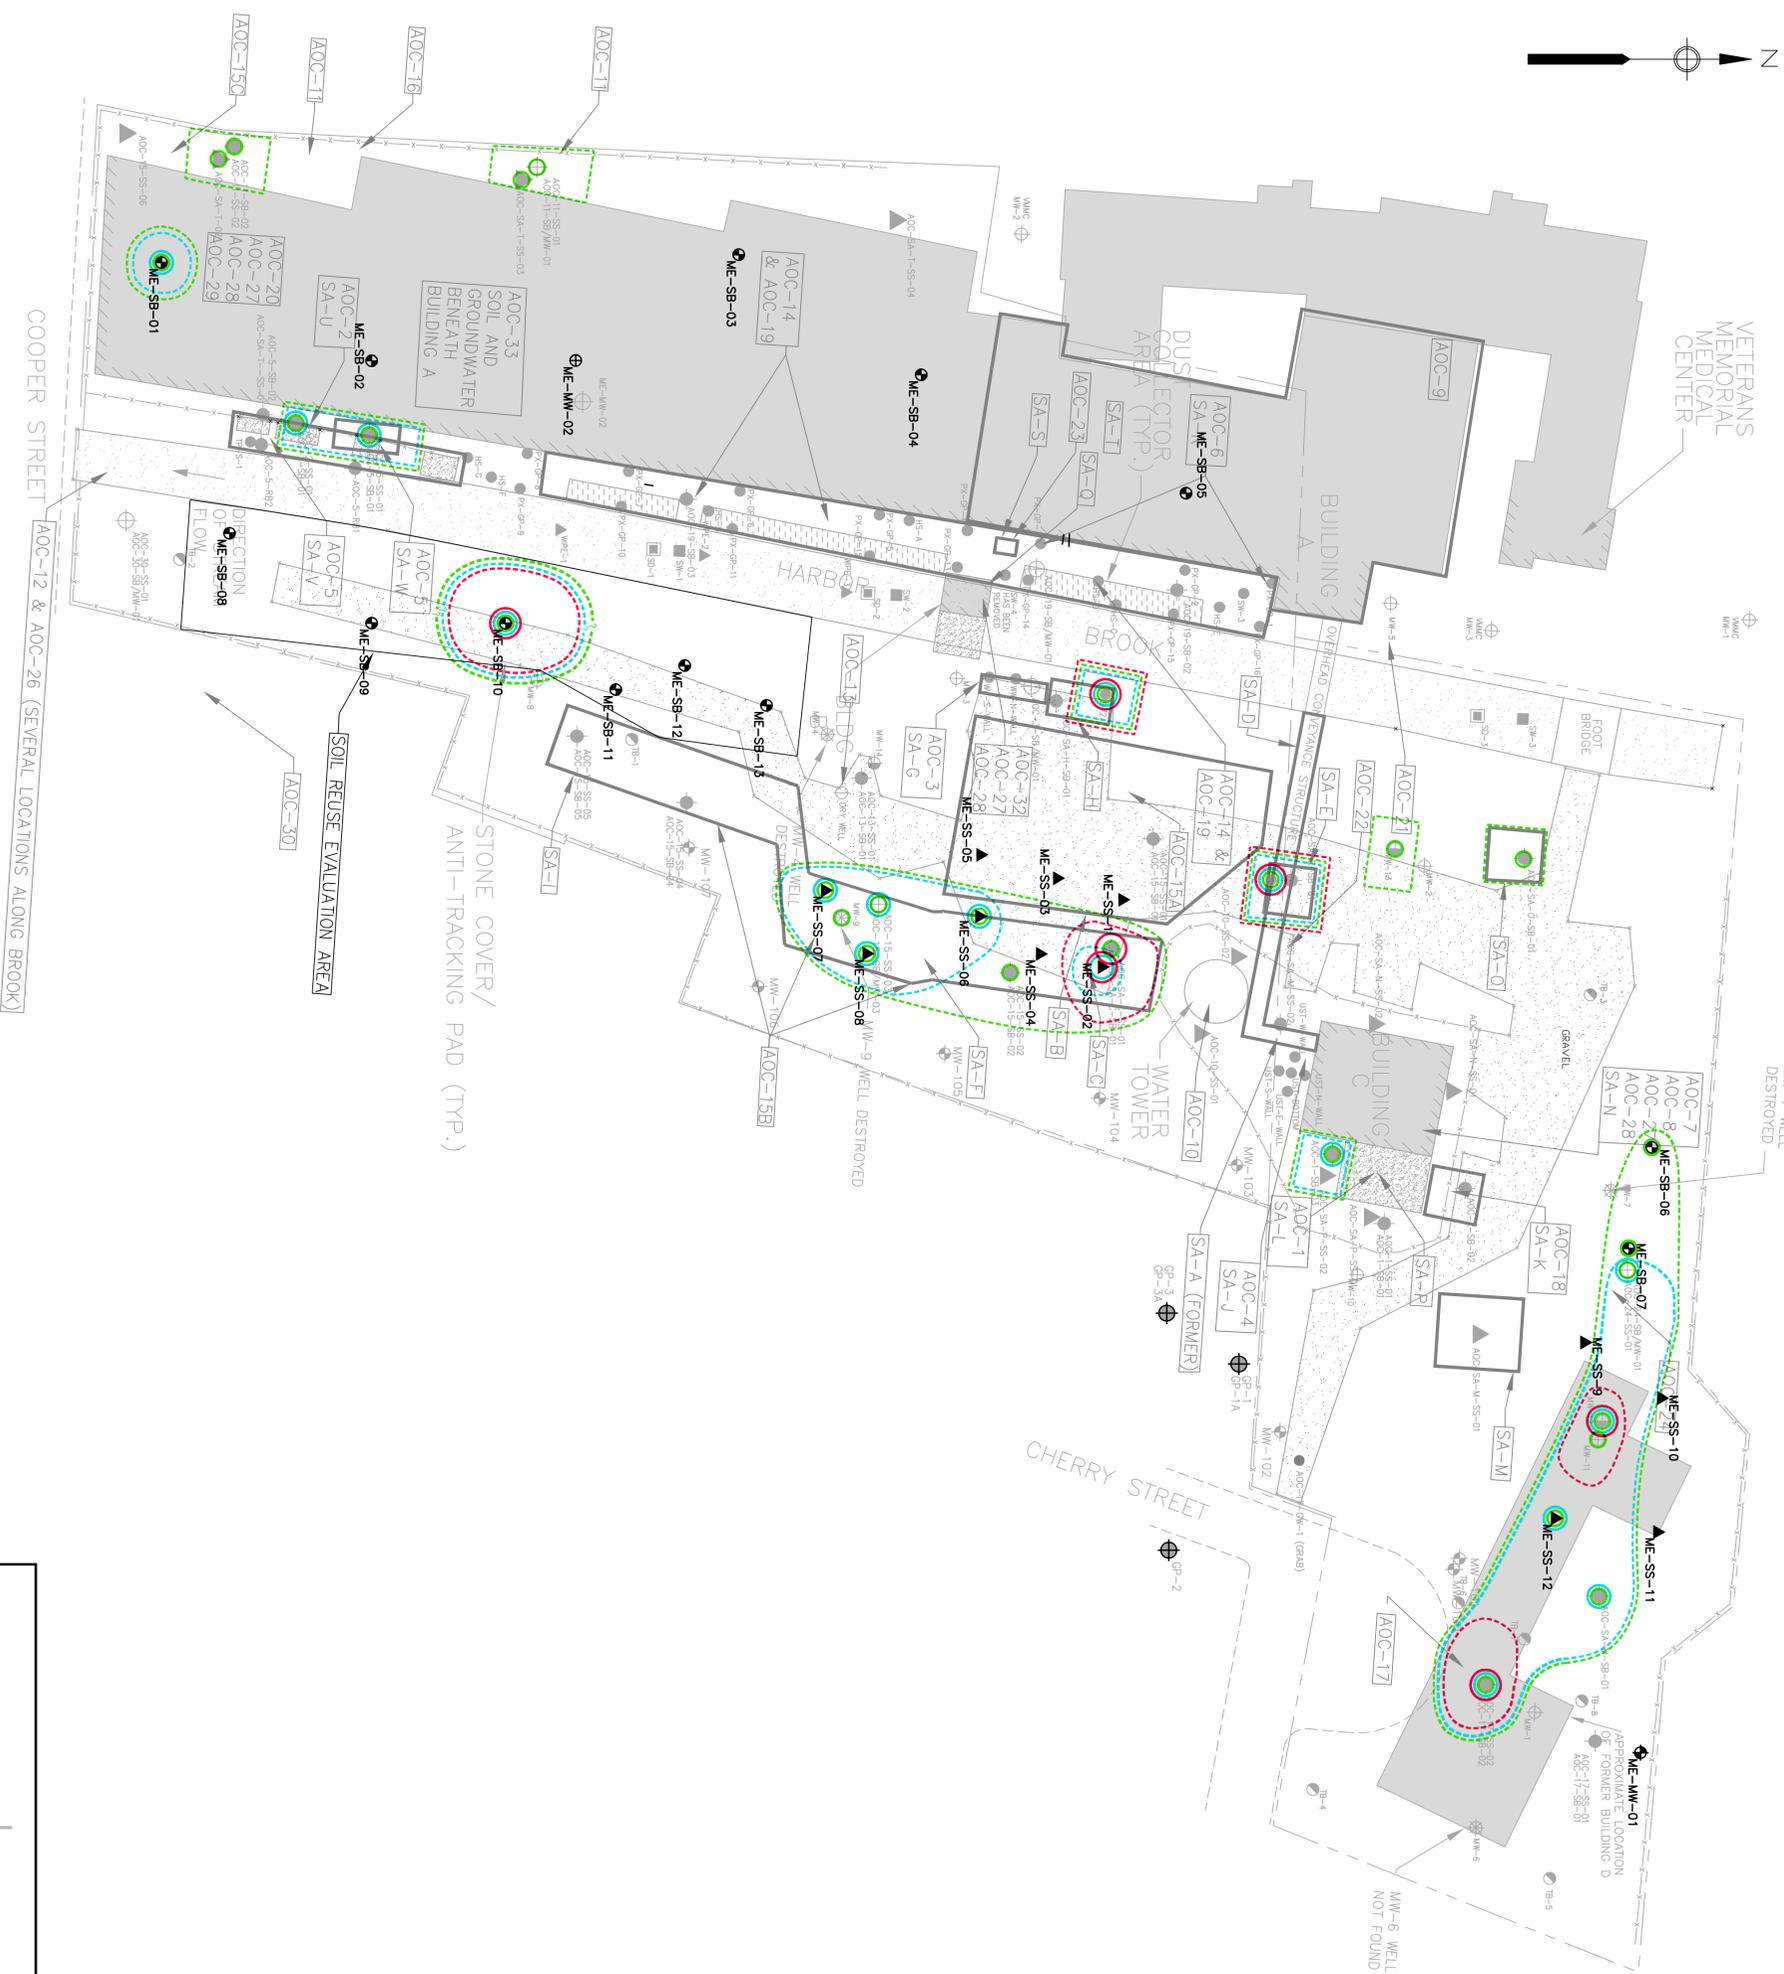
CITY OF MERRIDEN, CONNECTICUT
INTERNATIONAL SILVER COMPANY, FACTORY H
**FIGURE 4 – SOIL SAMPLES (0-2' BGS)
EXCEEDING RSR CRITERIA
SUPPLEMENTAL INVESTIGATION AND SOIL REUSE EVALUATION**
SCALE: AS NOTED DATE: JULY 2009

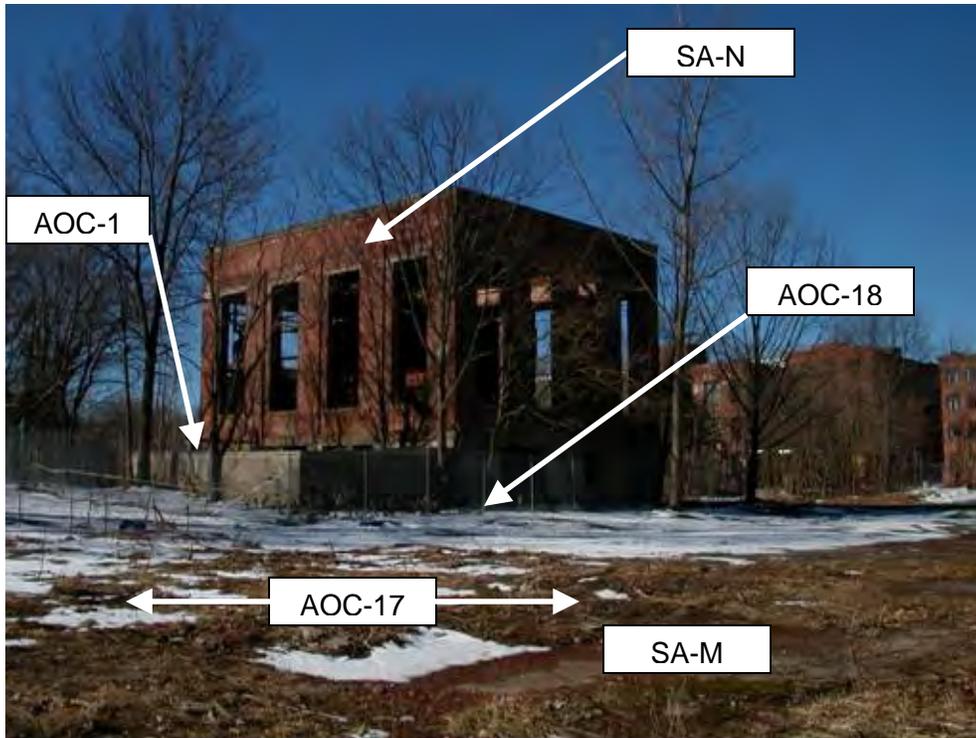
Photograph 1. View of Building C (former boiler house), AOC-1 (20,000 gallon UST bunker), and AOC-18 (oil-stained soil removal), facing west. Building A is in the background, while AOC-17 (chlorinated solvent-impacted soil) and SA-M (impacted soil and fire debris removal) are in the foreground. SA-N represents the removal of lead and asbestos-containing materials from Building C.

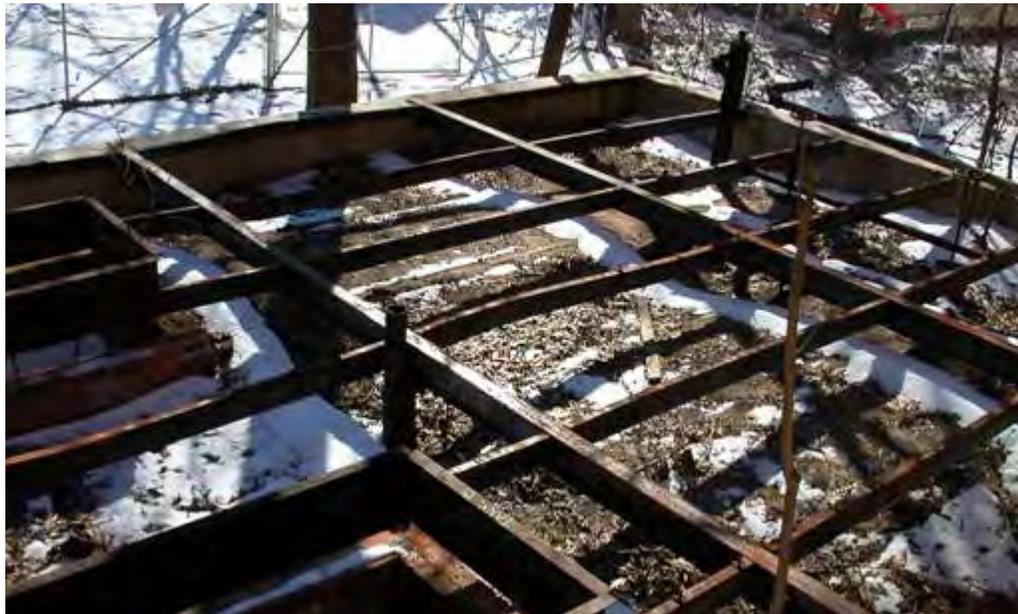
Photograph 2. View of deteriorated roof for AOC-1 (UST bunker). This roof represents SA-P and is a suspected source of asbestos-containing material.

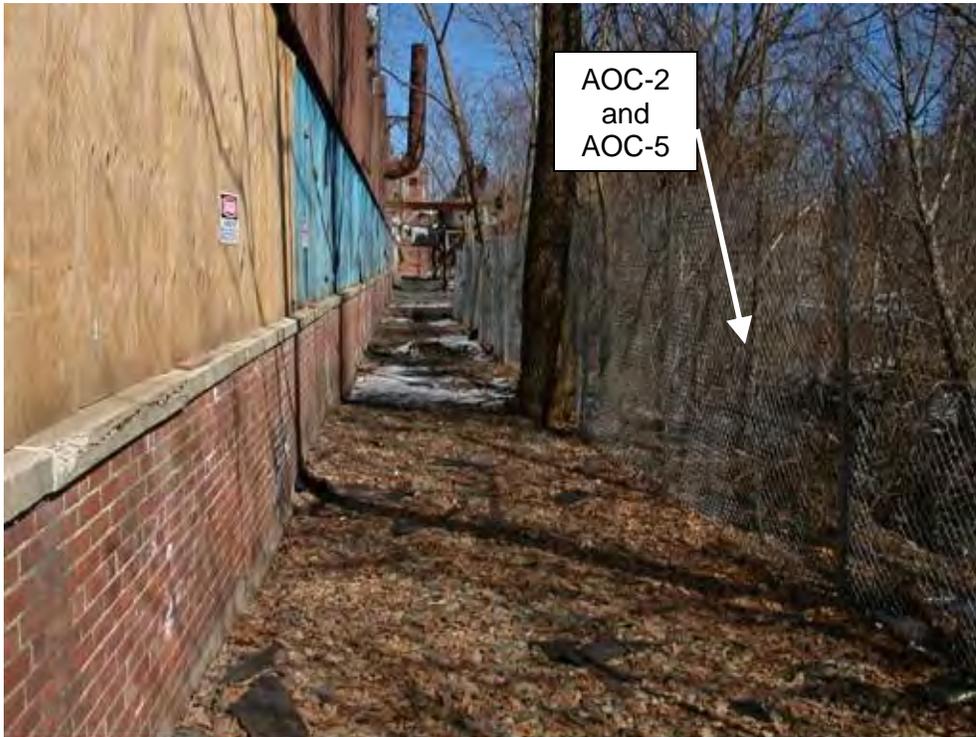
Photograph 3. View of AOCs 2 and 5 (USTs), facing to the north. AOCs 2 and 5 are located to the right of the fence between the brook and the southeastern side of Building A

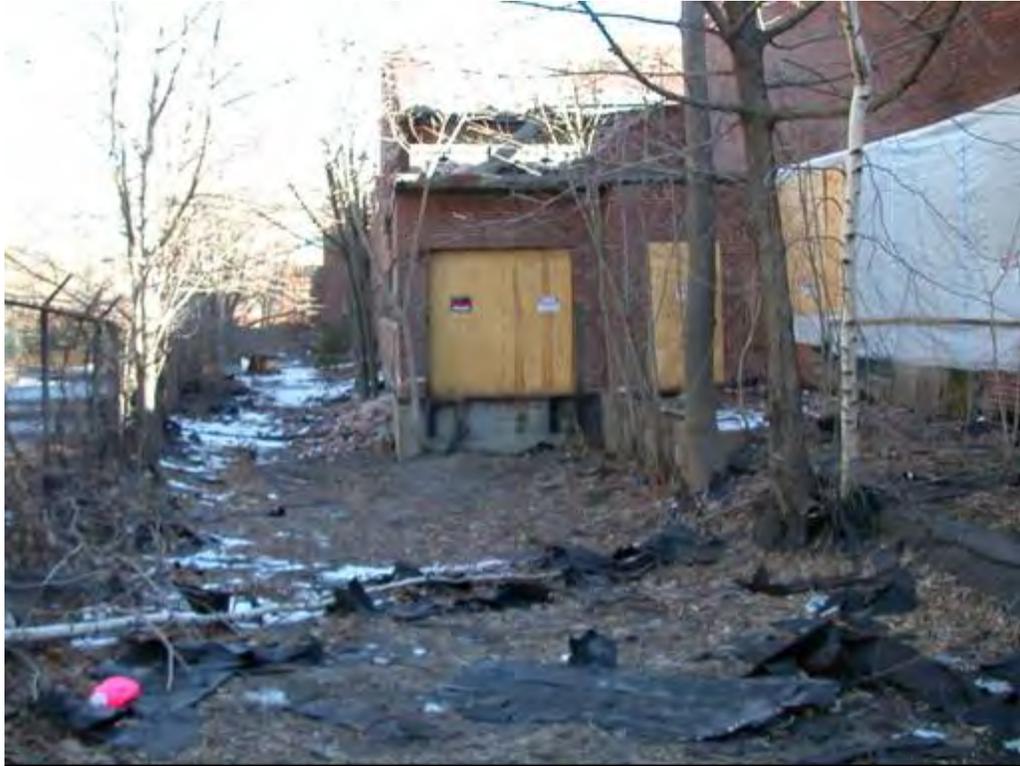
Photograph 9. View of AOC-11 (drum storage) and a portion of AOC-27/SA-T (asbestos-containing building materials).

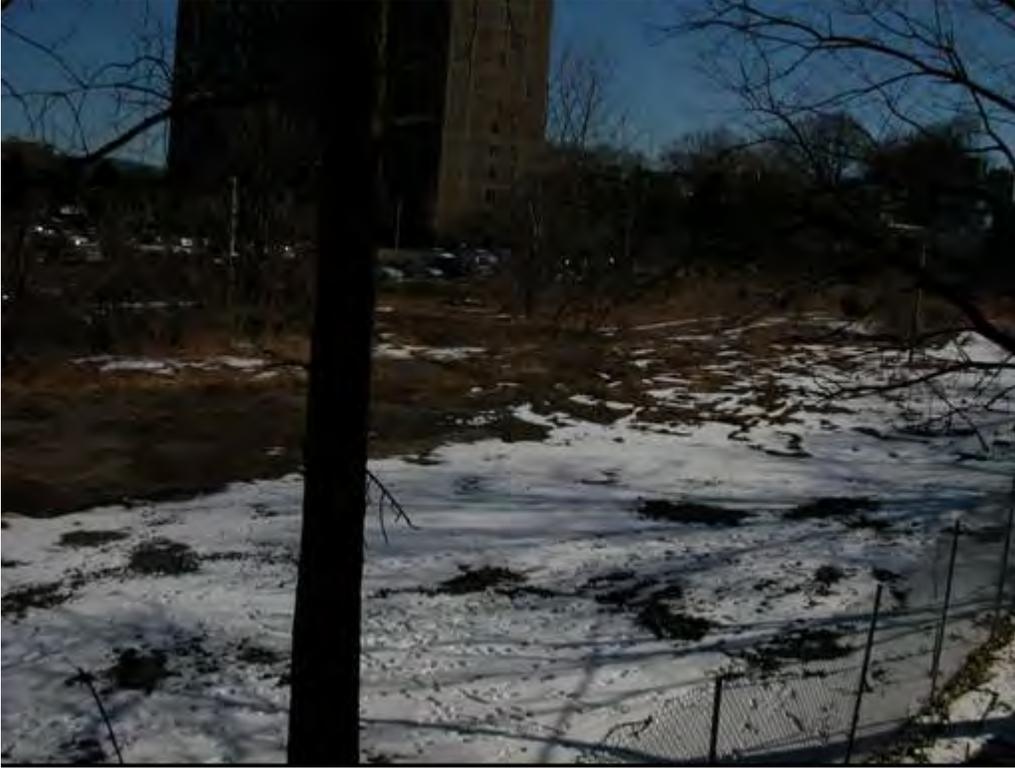
Photograph 17. View of AOC 17, located on the northeastern portion of the site, facing northeast.

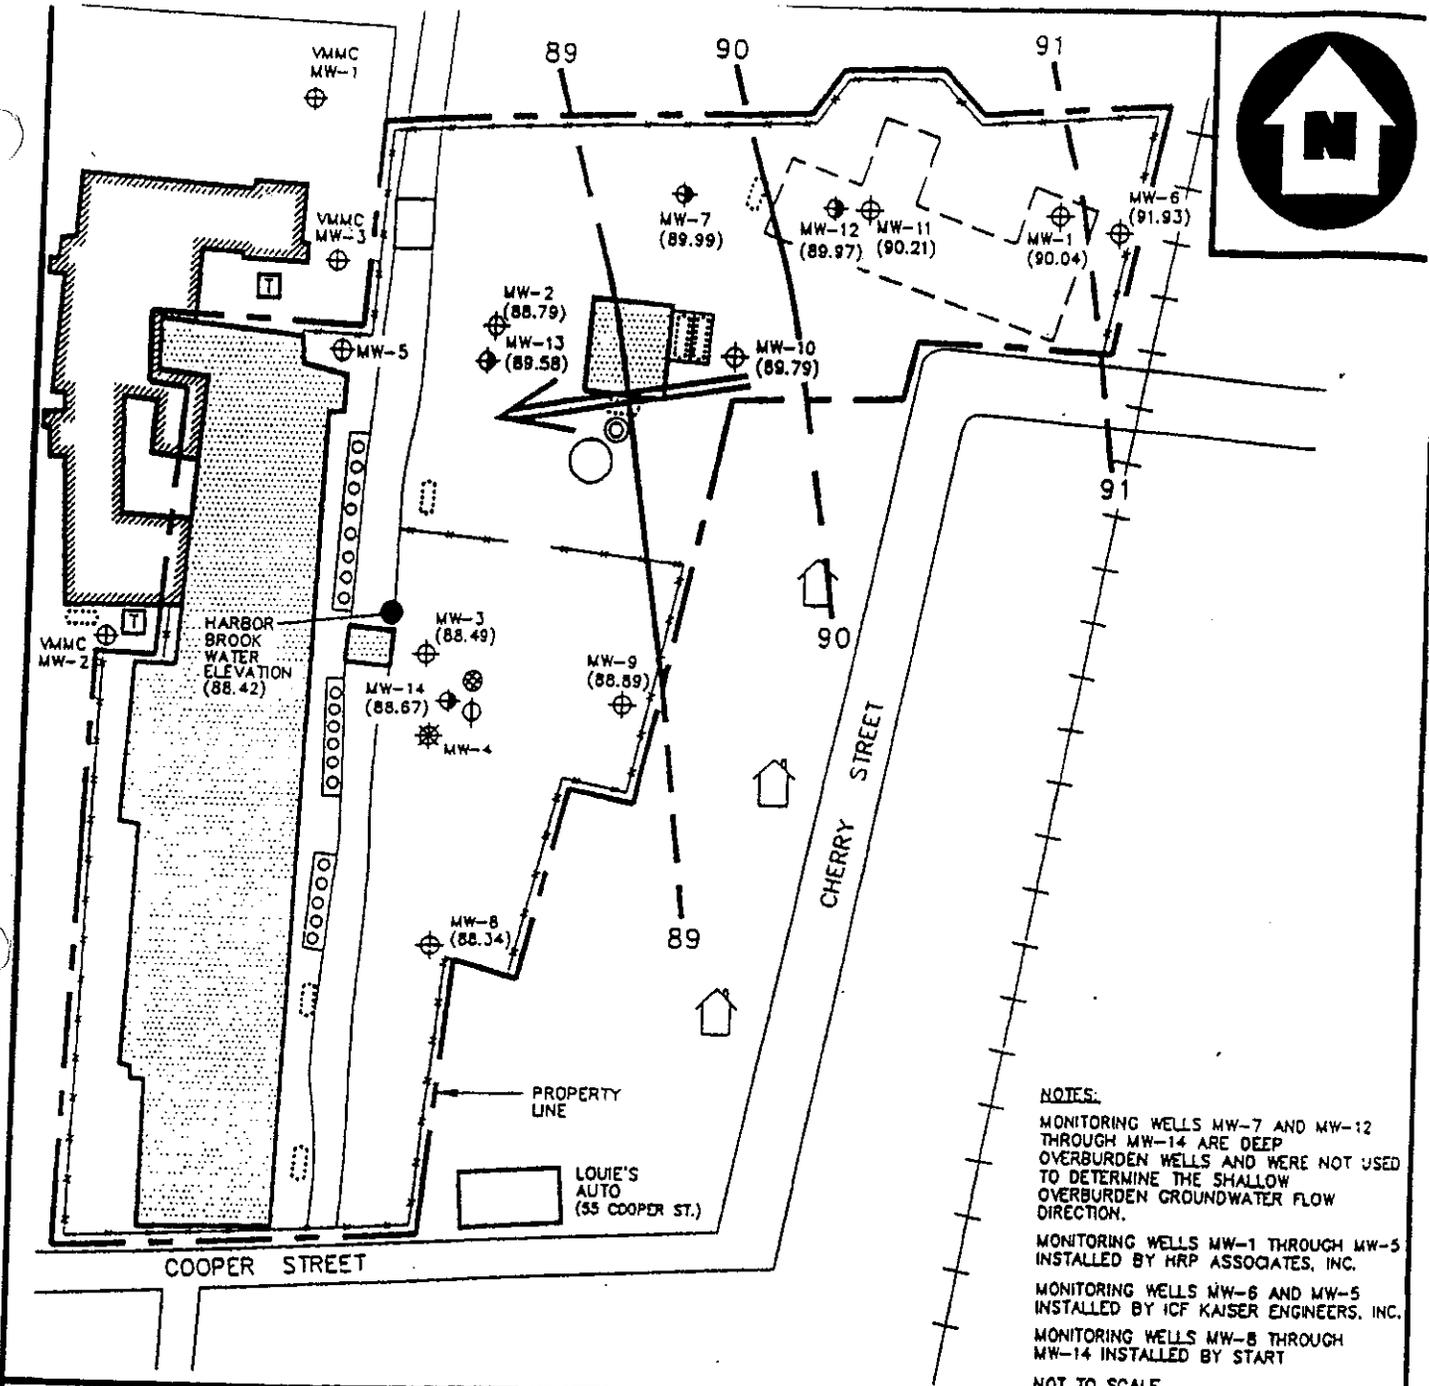
NOTES:
 MONITORING WELLS MW-7 AND MW-12 THROUGH MW-14 ARE DEEP OVERBURDEN WELLS AND WERE NOT USED TO DETERMINE THE SHALLOW OVERBURDEN GROUNDWATER FLOW DIRECTION.
 MONITORING WELLS MW-1 THROUGH MW-5 INSTALLED BY HRP ASSOCIATES, INC.
 MONITORING WELLS MW-6 AND MW-5 INSTALLED BY ICF KAISER ENGINEERS, INC.
 MONITORING WELLS MW-8 THROUGH MW-14 INSTALLED BY START
 NOT TO SCALE

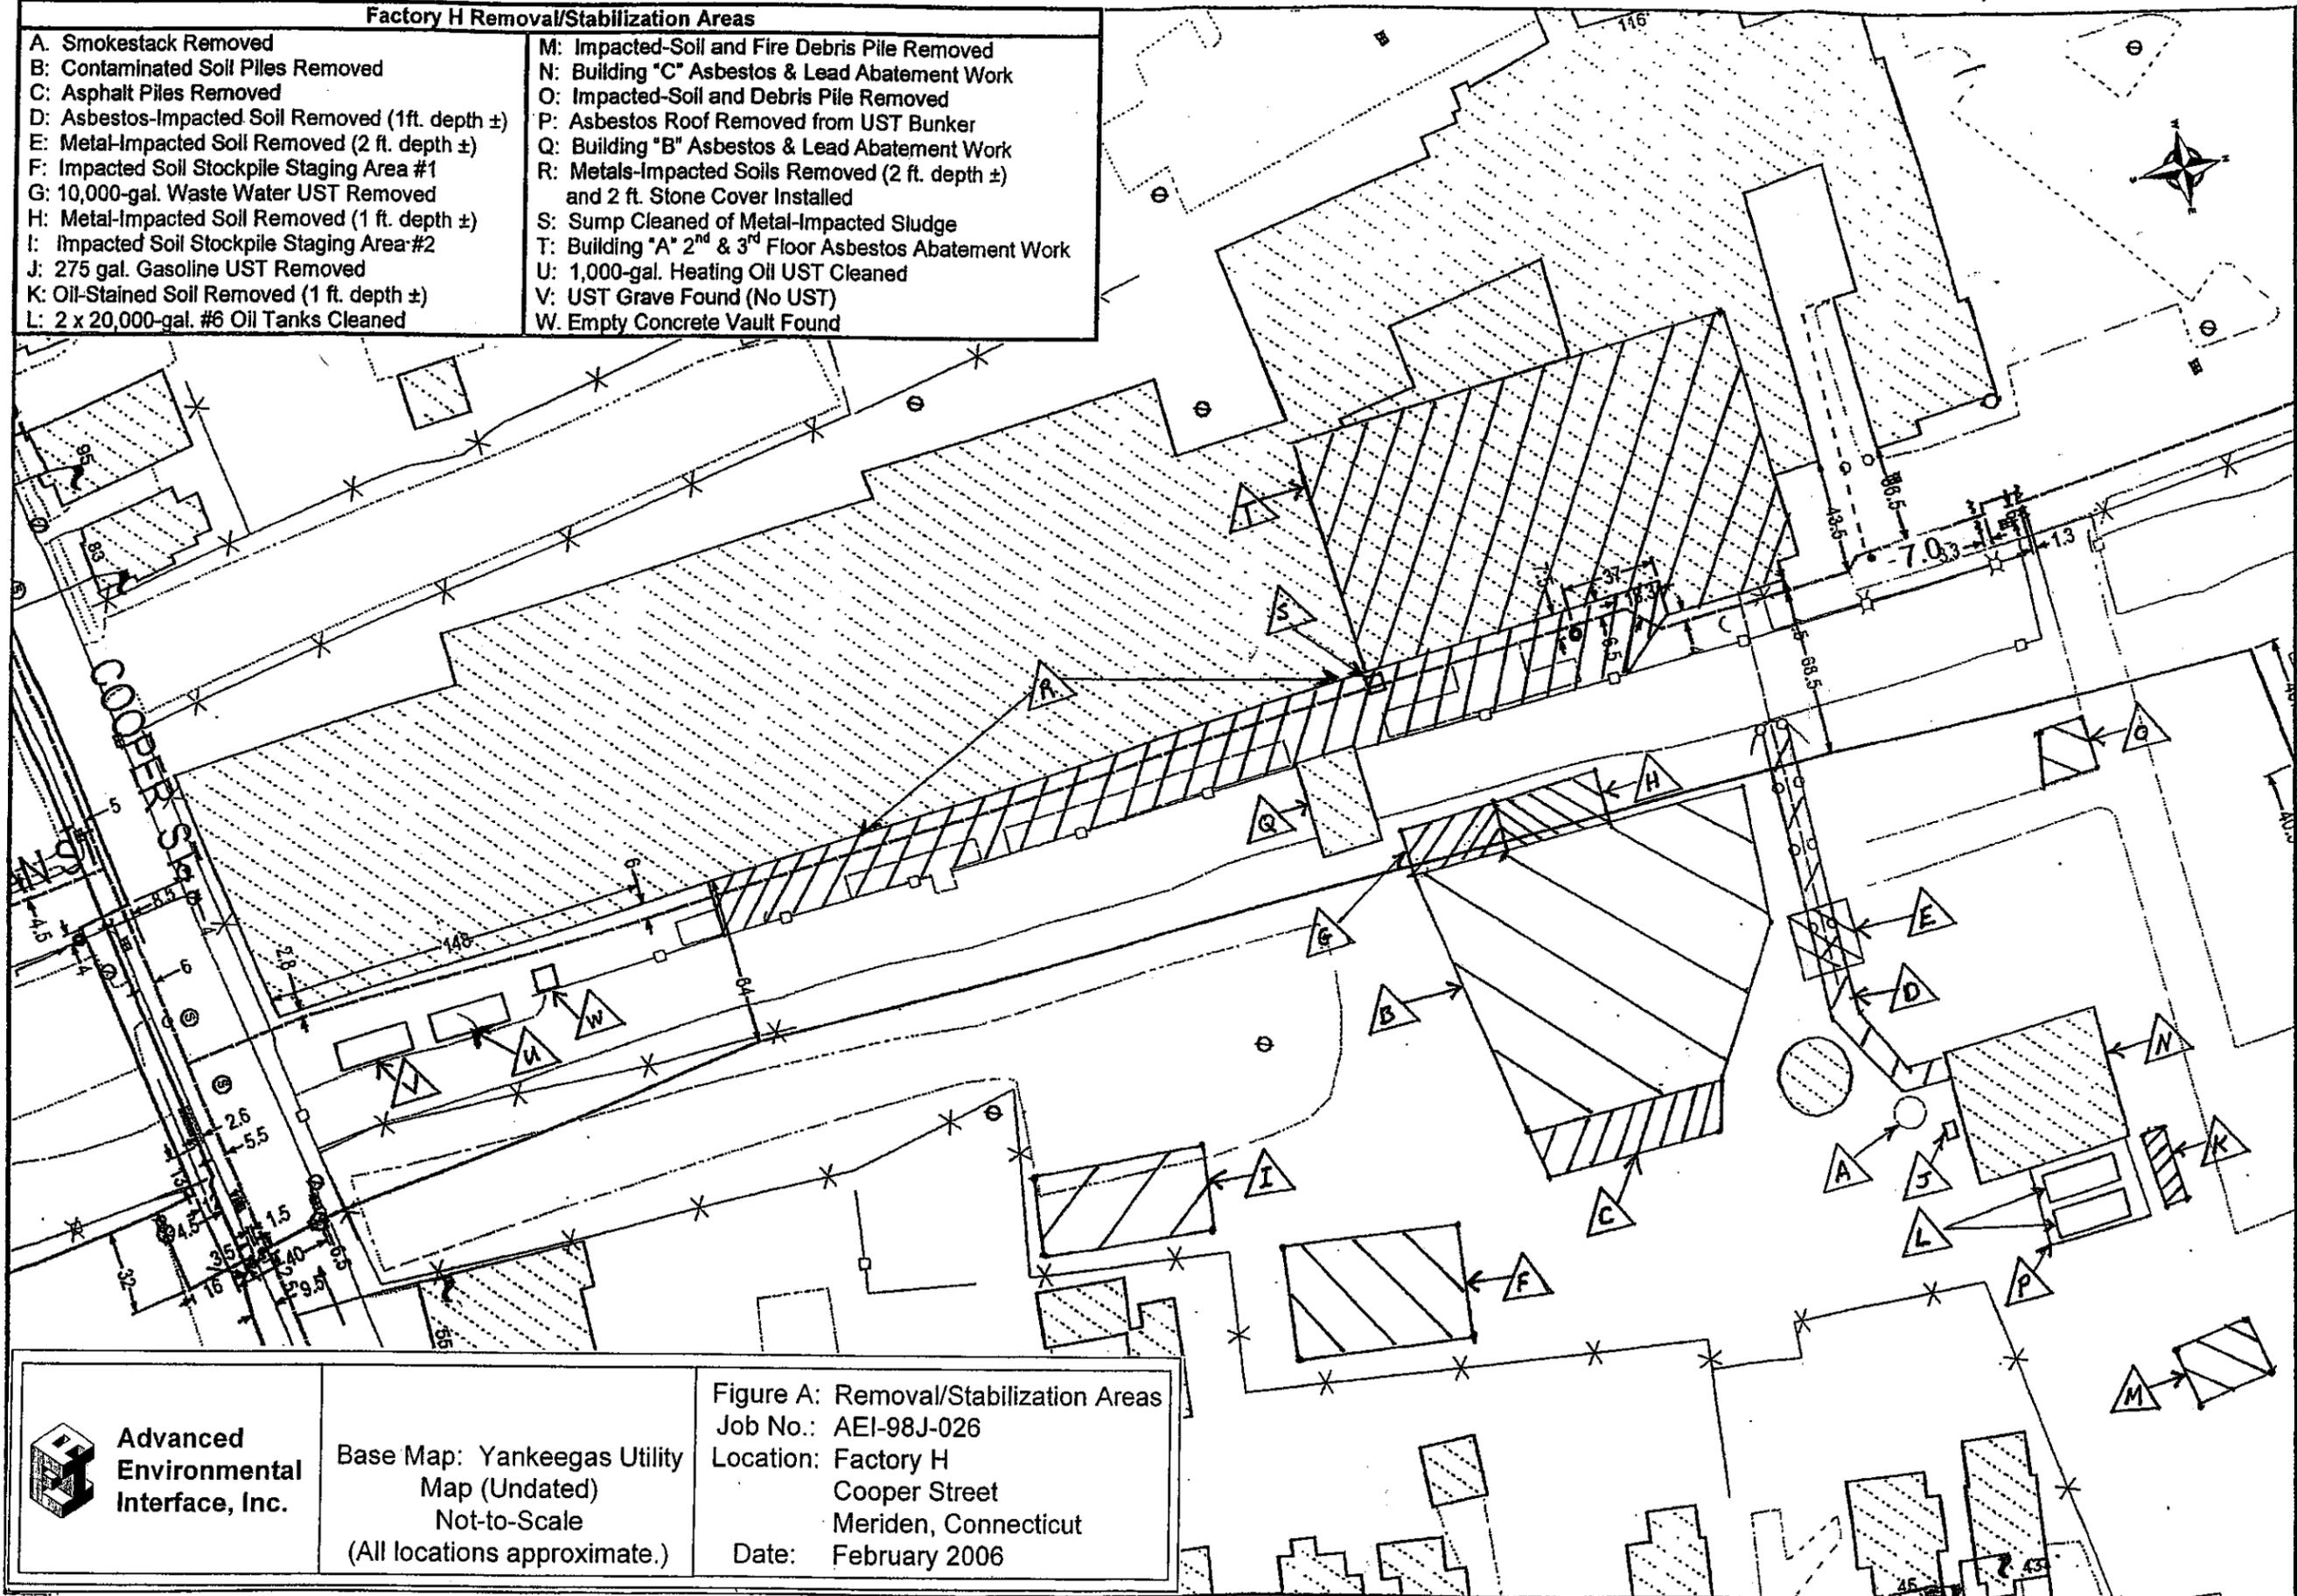
<p>Advanced Environmental Interface, Inc.</p>	<p>Base Map: Yankeegas Utility Map (Undated) Not-to-Scale (All locations approximate.)</p>	<p>Figure A: Removal/Stabilization Areas Job No.: AEI-98J-026 Location: Factory H Cooper Street Meriden, Connecticut Date: February 2006</p>
--	--	--
