**PHASE I ENVIRONMENTAL SITE ASSESSMENT**

**THE "HUB" PROPERTY**

**1 & 77 STATE STREET/30 & 50 EAST MAIN STREET**

**MERIDEN, CONNECTICUT**

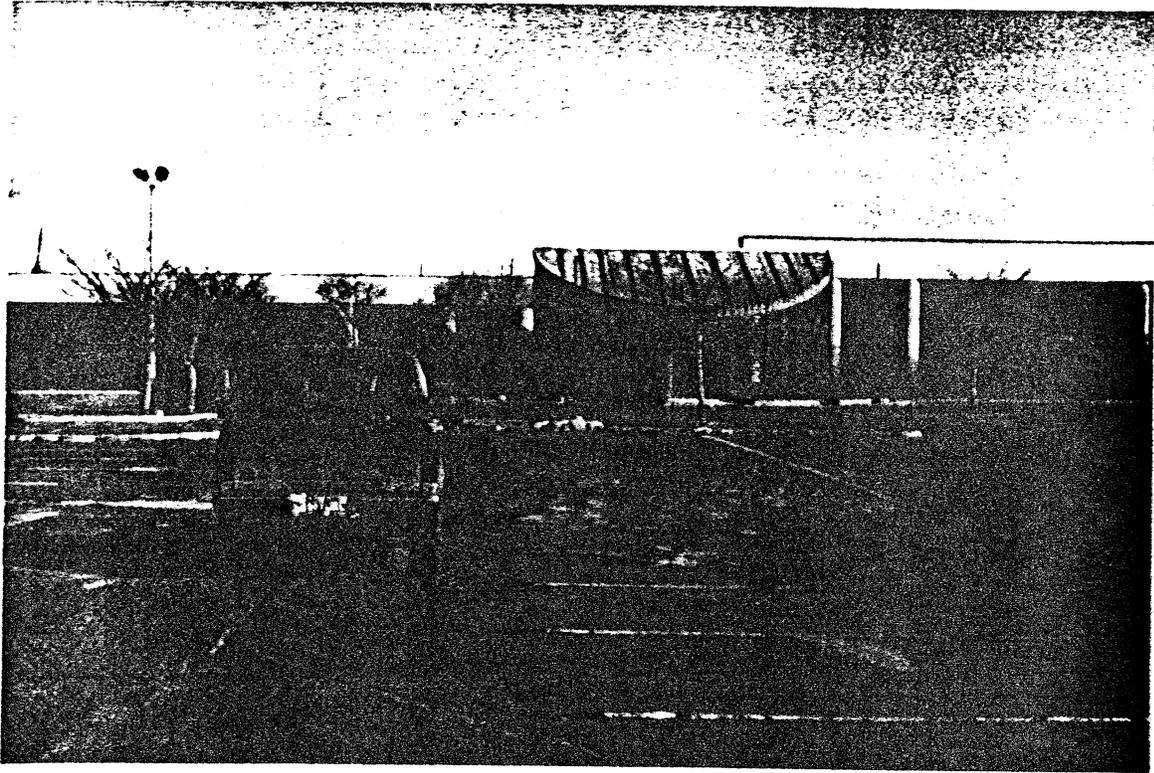
7. CANBERRA INDUSTRIES

A walk through of the facility was conducted on January 26, 1995 with Facility Manager, Michael Raicik. A map of the facility is presented in Appendix 2, Figure - 3 Canberra Facility. All areas of the facility were empty. The entire facility appeared to be clean and in excellent to moderately good condition. Floors appeared to be either carpeted or tiled. Only one floor drain was observed in the building located in the former machine shop. Neither the floor or drain appeared stained or dirty. One (1), empty, unlabeled 55-gallon drum was observed in the storage area near the basketball court.

Of the production areas: the wave solder area, machine shop, fabrication room, dark room, and detector room, only the floor in the detector room was dirty and slightly stained.

The hazardous waste storage room was clean and one section was bermed. The concrete floor and interior of the bermed area were unstained. However, the floor inside the berm was not coated with an impermeable material.

When the facility was in operation, a solvent, parts washer was located in a room off the fabrication area. The room is currently empty. However, according to Mr. Raicik, a container of unspecified size, was used to wash parts. A 55-gallon drum of virgin product was kept in the room as was a 55-gallon drum for waste solvent. No staining or spills were observed. Some solid waste was generated in the form of cleaning rags and these were also kept in a 55-gallon drum at this location.

One (1) tank, containing approximately 100-gallons of hydraulic oil was located in a large closet next to the elevator. It appeared in excellent conditions. No spills, leaks or stains were observed around the tank location.

The loading dock area was overgrown and a considerable amount of trash was scattered around the area. One (1) storm drain and an empty dumpster were observed in the area.

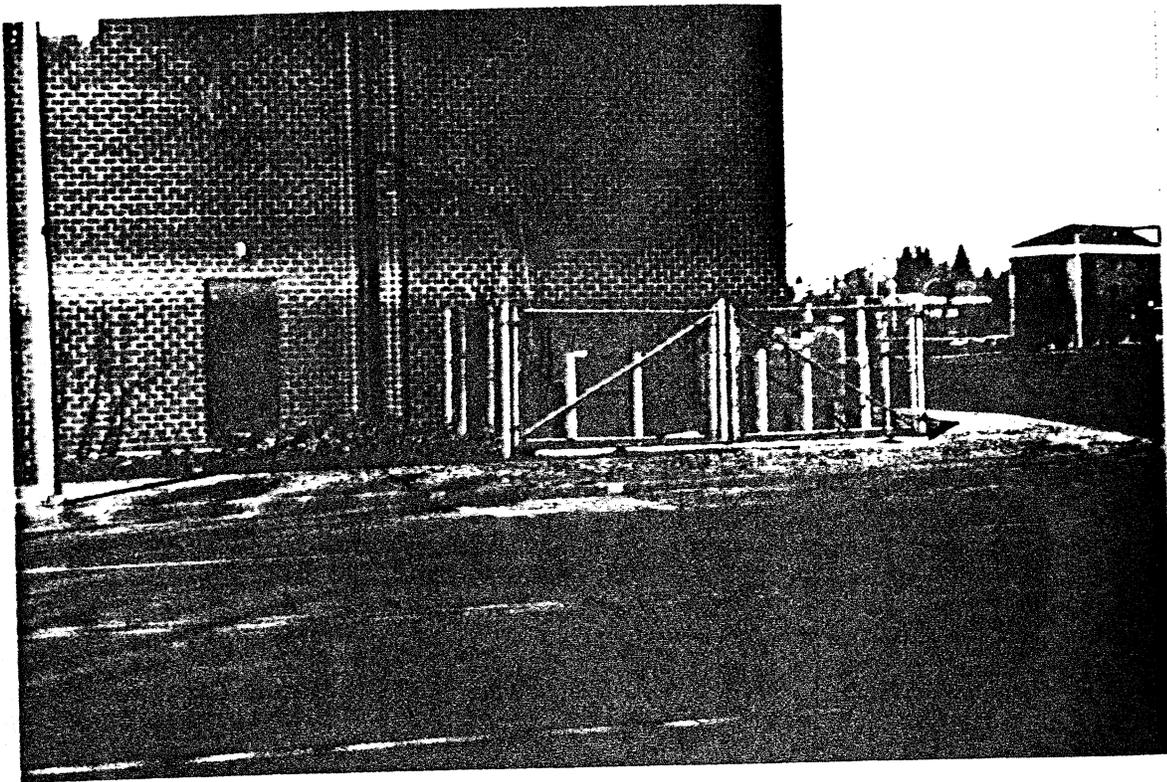
9. TRANSFORMERS #403 & #407

Five (5) transformers were observed on the Site grounds. All five are CL&P transformers numbers: 403, 407, 432, 433 and 434. All appeared to be in good conditions and no leakage or staining was observed around the transformers. However, transformers 432, 433 and 434 were difficult to observe carefully as they were partially enclosed by privacy fencing and bags of trash had been thrown into the enclosures.

According to Mr. Joe Crowley, of CL&P, unless the transformers have a label stating that they are PCB free they may or may not contain PCB's. The only way CL&P can confirm the status of a transformer without such a label, is to interrupt service and sample the transformer fluid for a fee. No PCB free labels were observed on the above mentioned transformers.

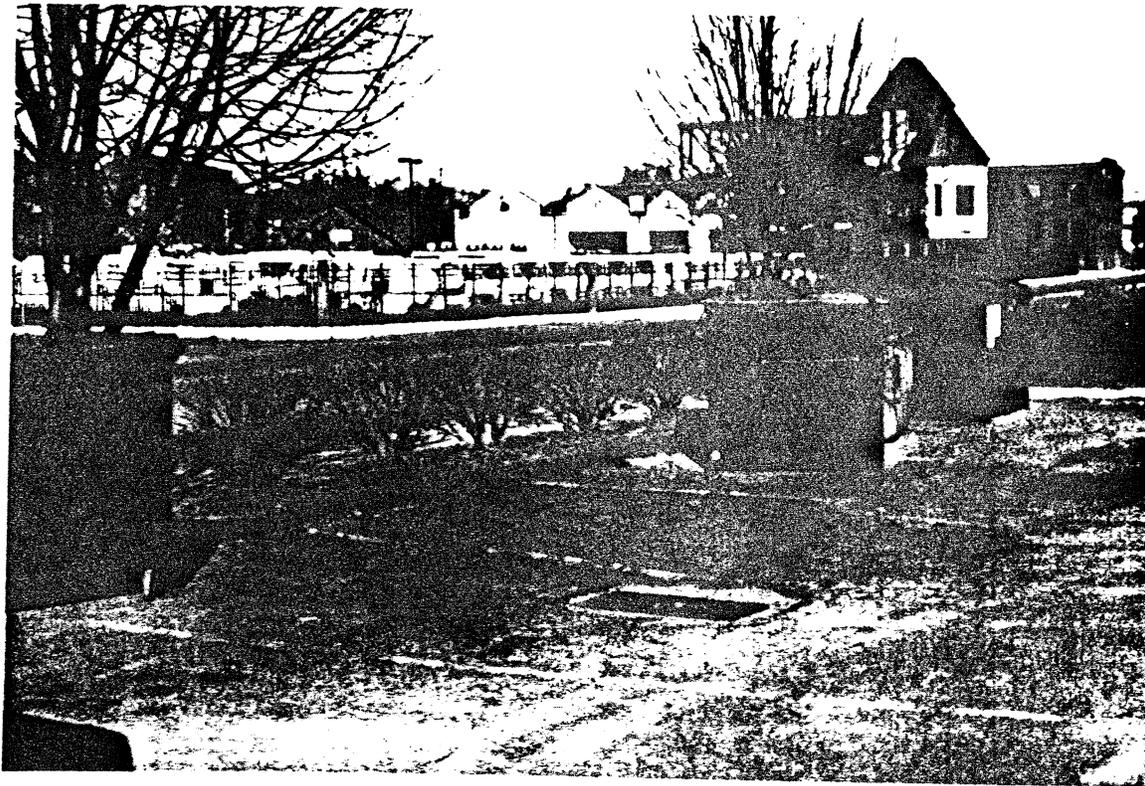
15. STATE STREET PARKING LOT - SOUTHWEST

- The two bank buildings are located in the southwest most portion of the parking area.
- Numerous storm drains are located in the parking areas as well as in the road, near the curb, along State Street, Mill Avenue, Pratt Street and East Main Street. No significant staining was observed around any of the storm drains.

- The following solid waste dumpsters were observed in the parking areas:
  - North Parking Lot (4)  
Tony's Trucking Co.  
Waste Management of Cheshire  
Western Mass Rendering Co.  
Waste Management of Connecticut

Although some trash and debris had overflowed some of the dumpsters, no significant staining was observed on the asphalt surface and no chemical containers were observed in or around the dumpsters.
